Important Product Notice

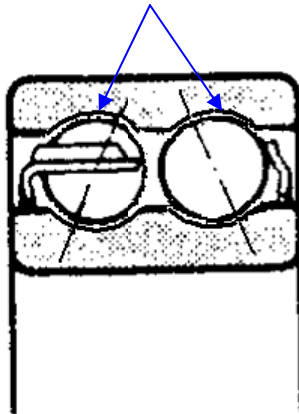
Radial Internal Clearance

When unmounted 5200 & 5300 series bearings are spun by hand, an audible clicking sound may be heard. This is due to the clearances internal to the bearing and **is normal**.

The use of proper shaft and housing fits is critical for achieving reliable bearing performance. After this bearing assembly is mounted, loaded, and properly fitted in the application, the excess clearance will be removed and the bearing will operate properly.
