## Not Just 52100 Needle Rollers

### The Challenge:

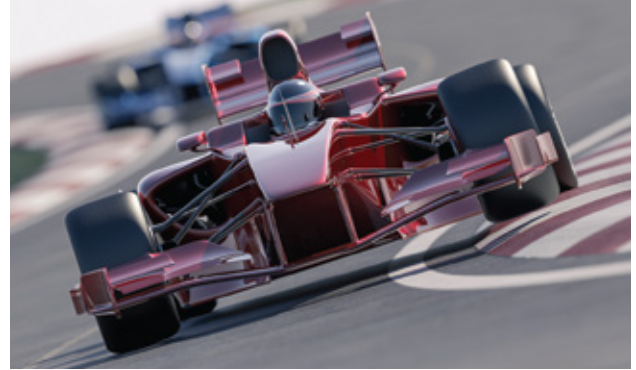
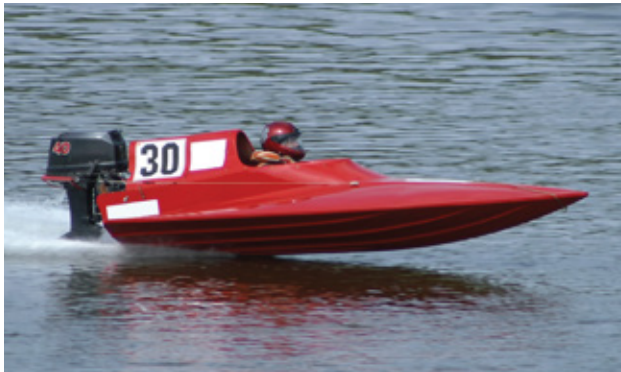
Racing on land and offshore presents some of the heaviest duty performance environments in which bearings and their components perform. A major racing and aftermarket customer needed a solution to catastrophic needle roller failures in racing engine valve lifters due to high temperatures and severe impact loading. Traditional rollers shattered and generated additional engine damage.

Although not at all a typical failure, Koyo engineers found the customer's rollers were shattering due to the relatively brittle nature of standard through hardened 52100 steel when placed under high temperature, low lube, and high impact loads.

Using their extensive knowledge of materials, Koyo engineers recommended a tool steel with optimized thermal treatment which dramatically improved needle properties to better withstand the high temperature loading experienced in racing engine valve lifters.

Koyo engineers also designed an optimum roller contour to better distribute contact stress over the roller length.

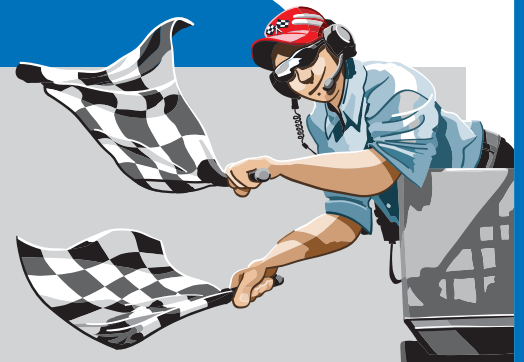
After converting to the tool steel rollers, roller shattering was eliminated. The customer has subsequently expanded this solution to other applications where high temperature due to inadequate lube flow was an issue.
